Manhole Inspection Summary

Manhole # S29S__006MH

Insp Date: **10/30/08 1:56 PM**

Location Address: **Ridgely St.**

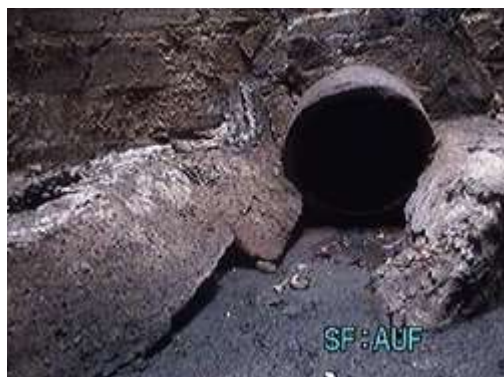
Defect 4

Condition: ☐ Sound ☒ **Cracked** ☐ Root Intrusion ☒ **Deteriorated** ☐ Leaks ☐ Debris

bench deteriorated & cracked

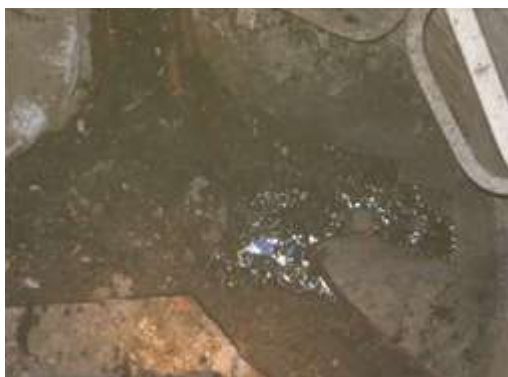
Defect 3

Condition: ☐ Sound ☐ Cracked ☐ Root Intrusion ☐ Deteriorated ☐ Leaks ☒ **Debris**

debris in channel

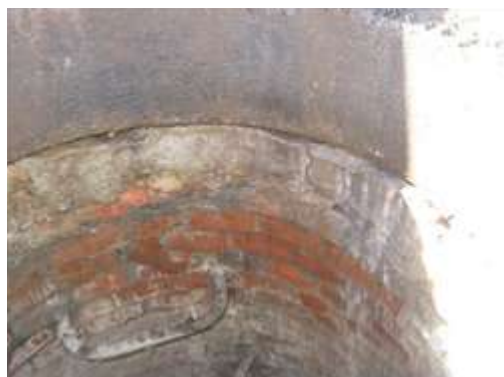
Defect 2

Infiltration: ☐ None ☒ **Joint** ☐ Cracks ☒ **Mortar** ☐ Roots ☐ Wall

Infiltration: ☐ None ☐ Joint ☐ Cracks ☒ **Mortar** ☐ Roots ☐ Wall

infiltration from chimney and corbel at mortar

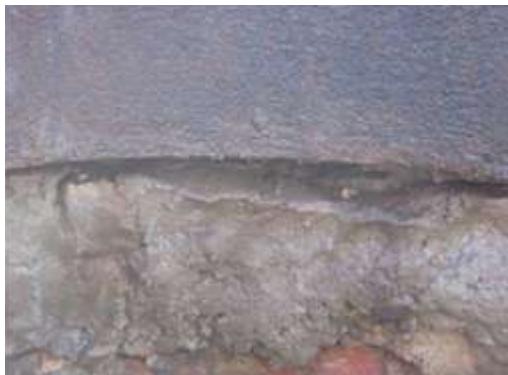
Defect 1

chimney joint infiltration

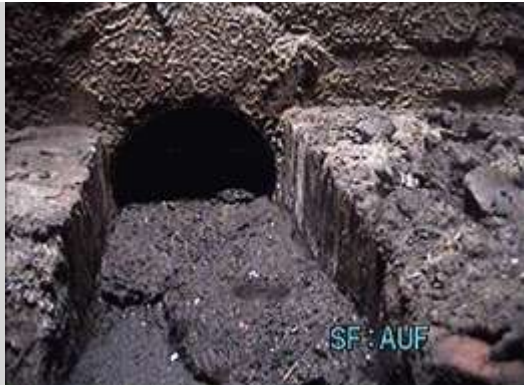
5 O'Clock Inflow

Deposits: ☐ None ☐ Mud ☐ Sludge ☒ **Debris** ☐ Grease

Silt Depth: **0** (in.) Deposits Extent: **Medium**

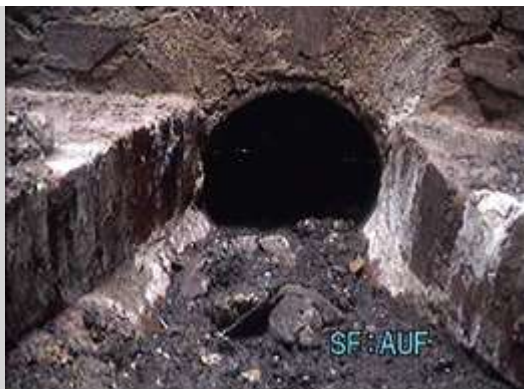
9 O'Clock Inflow

Deposits: ☐ None ☐ Mud ☐ Sludge ☒ **Debris** ☐ Grease

Silt Depth: **3** (in.) Deposits Extent: **Light**
